SALT RUN RESERVOIR DAM

NDI No. PA 00392

PHASE I INSPECTION REPORT
NATIONAL DAM INSPECTION PROGRAM

February 1979

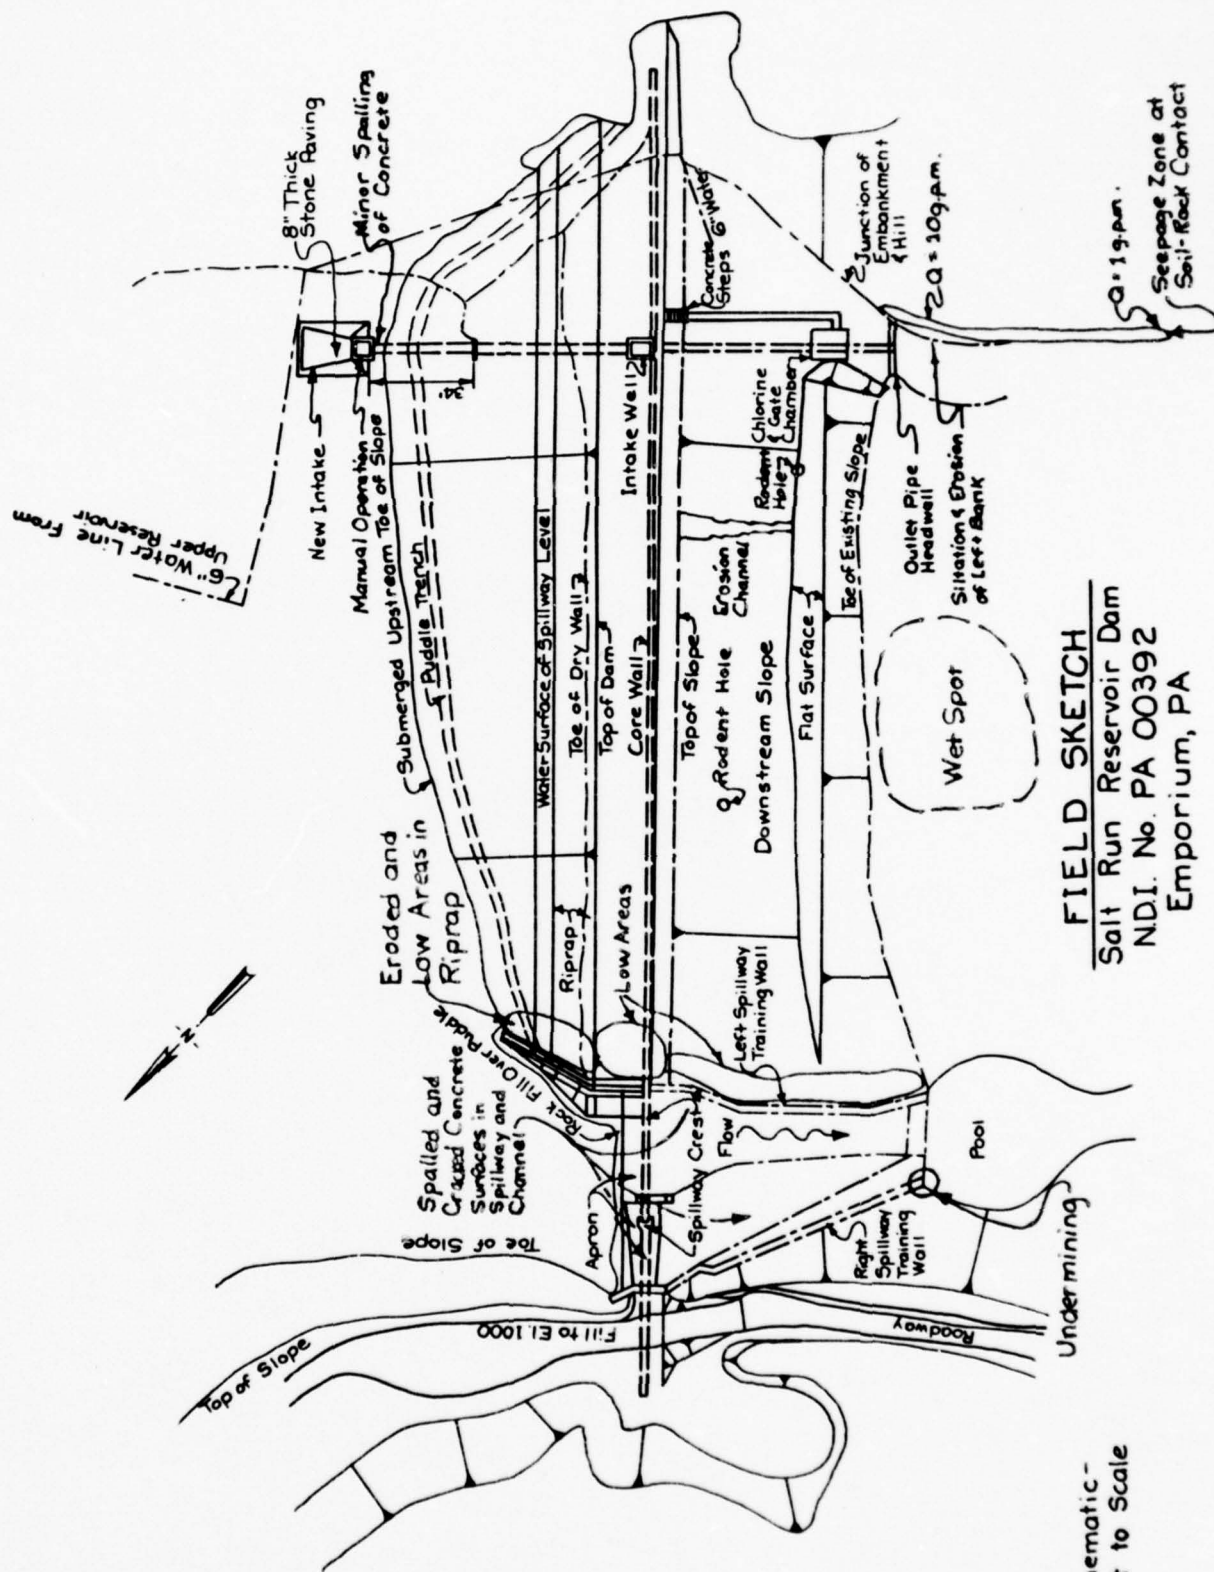
**Schematic-
Not to Scale**

A wet, marshy area extending from 160 feet to 200 feet left of the right abutment was observed at the toe of the embankment. The area is approximately 40-foot by 50-foot in plan view and is shown on the field sketch in Appendix A. This area may have resulted from ponding of surface water runoff, since the area is not properly graded for adequate drainage. Proper drainage should be provided, and the area should be observed for seepage from the dam.

Two animal burrows were observed in the embankment. The locations of these holes are shown on the field sketch in Appendix A. Both holes should be repaired, and a rodent control program should be implemented.

Erosion was observed in several areas on the embankment during the visual inspection. The eroded areas consist of an erosion channel on the downstream slope, the embankment crest near the junction of the embankment and the left spillway wall, and the downstream embankment along the left spillway training wall. These areas should be restored to their original elevation and reseeded to prevent future erosion. Erosion was also

observed along the upstream riprap near the left wing wall of the approach channel. The riprap at this location should be repaired to prevent future erosion. The approximate locations of all the eroded areas have been included on the field sketch in Appendix A.
